RMS TITANIC

TITANIC HULL FAILURE

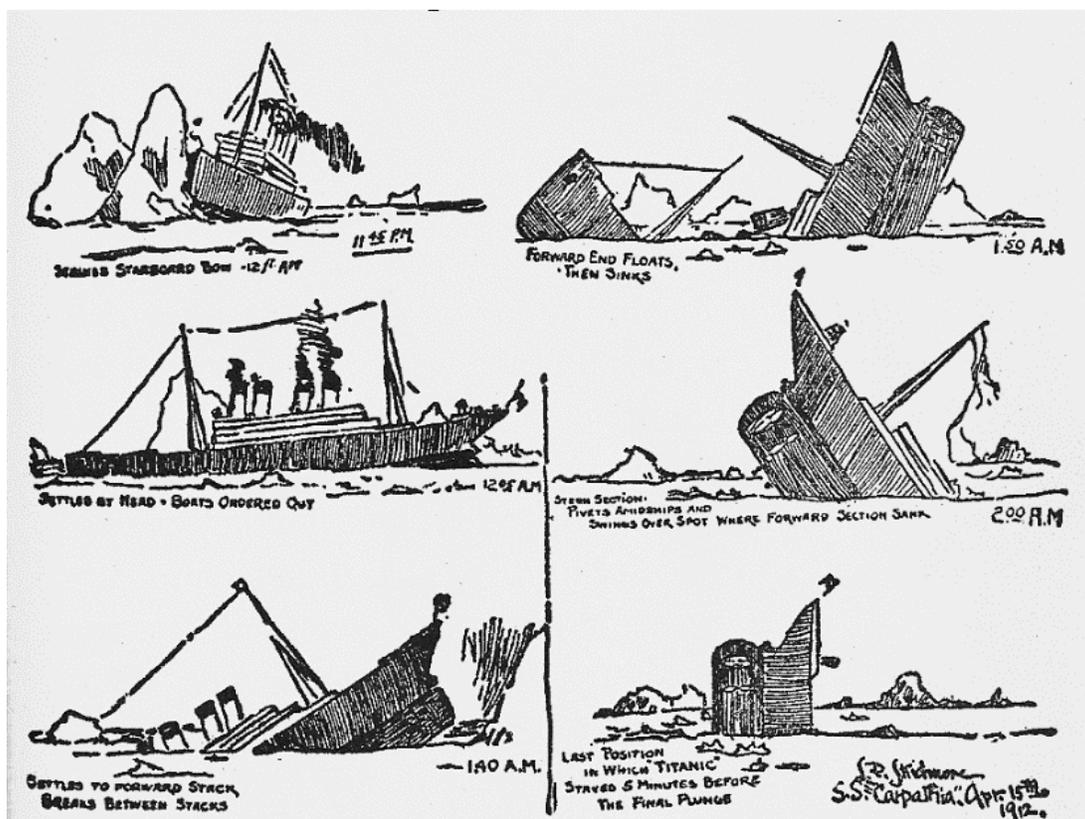
Survivor Jack Thayer's Illustration of the sinking
Credit: Wiki Commons

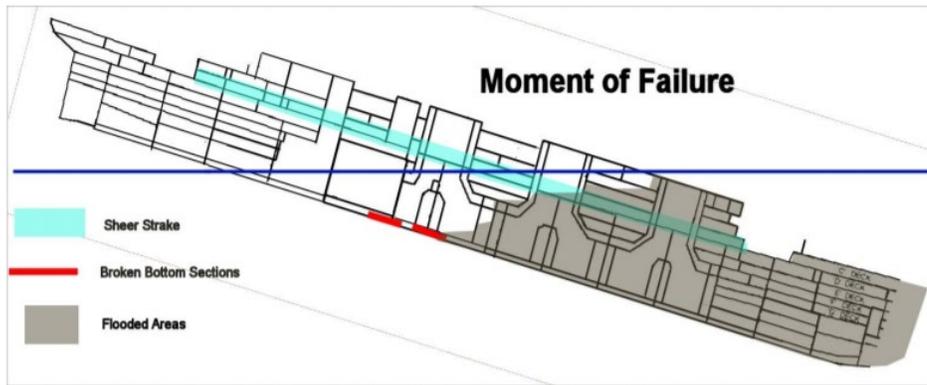
Figure 8 – Moment of Initial failure

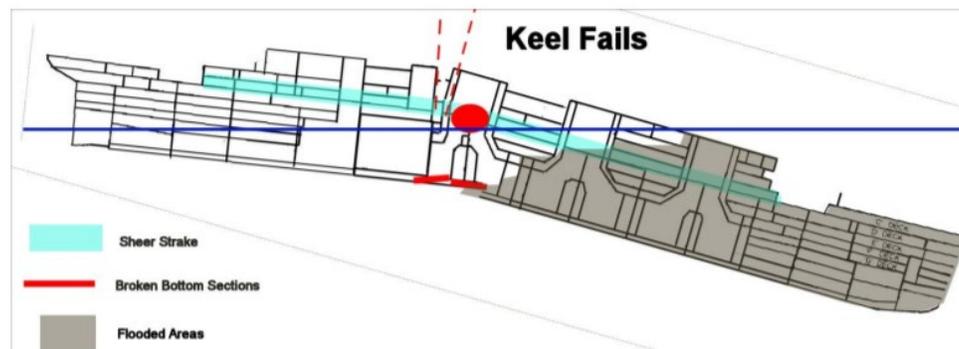
A detailed failure sequence of the double bottom structure is beyond the scope of this post, but calculations revealed that the bottom possessed about 83% of the strength of the heavily constructed, doubled upper hull plating, known as the sheer strake and strength deck. Suffice it to say that various structural features contributed to the ship's bottom failure: the reduction of the double bottom depth from about 6 to 5 feet between the reciprocating engine room and Boiler Room #1; the presence of 3 manholes transversely across the inner bottom plating in Boiler Rm. #1, forming natural weak spots; the abrupt ends of longitudinal framing to support the reciprocating engines; and so forth. While Titanic was well designed to withstand the rigors of extreme winter North

Figure 9 - Initial failure of the double bottom

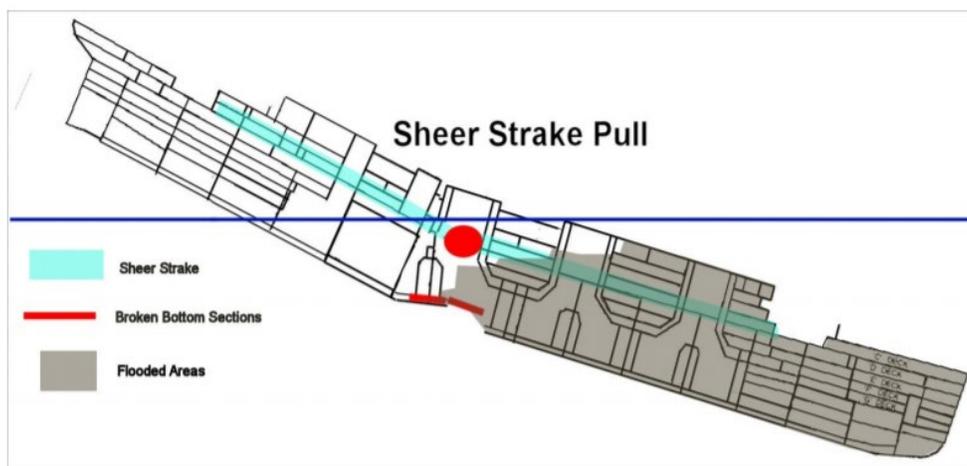
During Titanic's cataclysmic self-destruction, the stern slowly settled back. As her bow sank deeper, the upper midship portion of the hull remained partially attached, the fore section hauling the still floating stern down until the dwindling connection between bow and stern finally ruptured. During this convulsion, the stern twisted violently around to port, floated briefly on its own, then disappeared under the sea.

Figure 10 - The bow section pulls downward on the stern section
