# A QUIET SEA

## RMS TITANIC

## TITANIC BULKHEADS

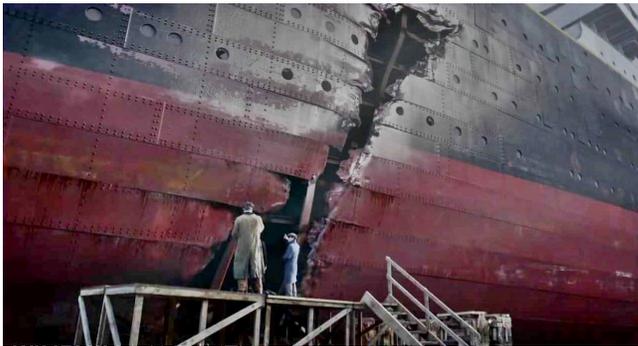
Olympic collision damage  
Photo credit: Pinterest

Not long after Olympic began service in June 1911, she collided with the Royal Navy cruiser HMS Hawke. Olympic was outbound to New York from Southampton and encountered Hawke in the Solent, a 20-mile strait between the Isle of Wight and Great Britain. Both vessels were on converging courses and shaping up for the seabound channel. Hawke, either through loss of steering or suction from Olympic’s large hull, was uncontrollably drawn into the liner and rammed her in the starboard aft quarter, just forward of the stern. Hawke’s bow crumpled, her fore deck buckled and she lost her ram bow.

Olympic also sustained serious injury. She suffered two flooded compartments and damaged her starboard propeller. Accommodations and electrical systems in the collision area were destroyed. When the turning starboard propeller came into contact with Hawke, the propeller slowed, possibly straining the engine and raising concerns among the engineers. Olympic anchored after the collision and was towed to her builders, Harland & Wolff, for repairs. Though badly damaged, Olympic was in little danger of sinking, proof to many of the invincibility of this class of liner.

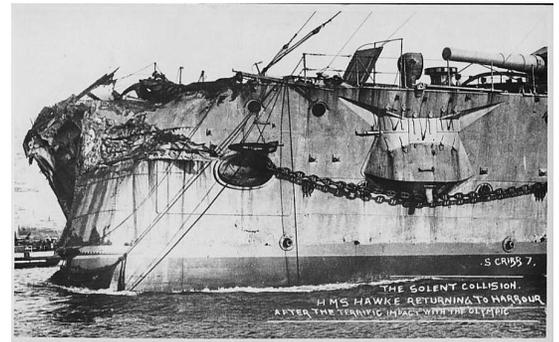
Hawke bow damage  
Photo credit: Reddit

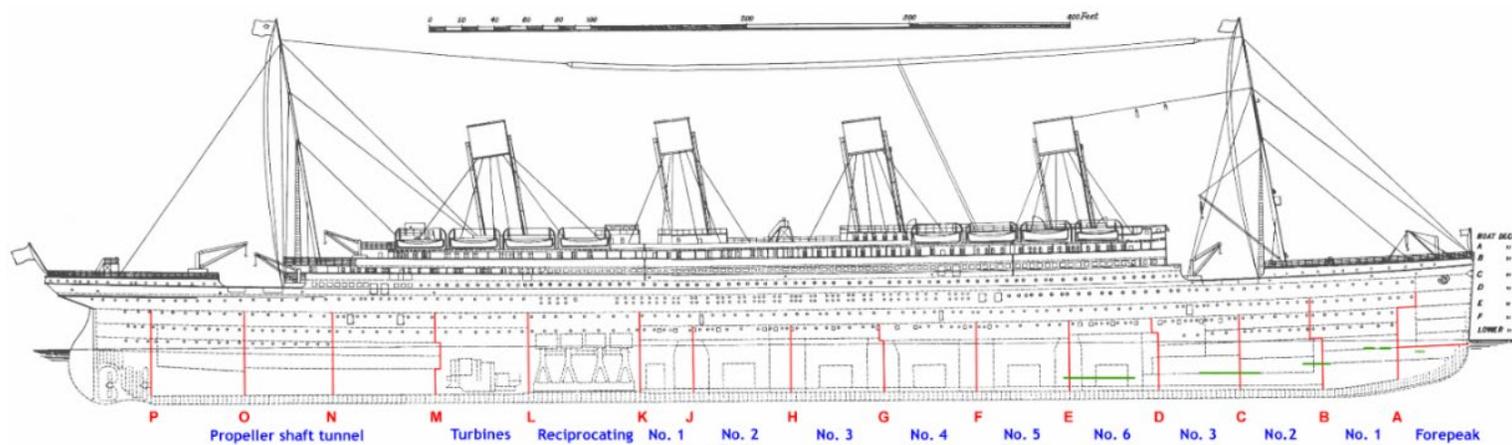
Titanic subdivision (Olympic shown, bulkheads in red)

During one of Titanic’s post-sinking inquiries, Edward Wilding, one of the naval architects responsible for the design, estimated the initial rate of flooding to be about 250 tons of water per minute. Naval architects try to determine how a ship will respond to flooding using what is known as the floodable length curve. A ship is designed to sustain flooding for an allowable portion of her length and remain afloat. The floodable length curve specifies this value and determines the number and spacing of the bulkheads. Also included in these computations is the margin line. The margin line is

calculated to be several inches below (hence the margin) the tops of the bulkheads, or watertight deck, if one is fitted. It represents the lowest level to which the ship can sink yet remain afloat. Bulkheads also perform the vital function of structurally joining together the bottom, sides and decks of a ship.

Titanic was provided with 15 watertight bulkheads and could safely remain afloat with any two compartments flooded, meaning that one ruptured bulkhead wouldn't drastically impair the ship's floatation. Titanic's 16 compartments were from 50 to 70 feet long, so the anticipated worst-case scenario would flood about 120 feet of the ship's length. Titanic could also remain afloat with her first four compartments flooded, about 200 feet of her length, from the stem to the bridge. But collision with the iceberg opened seams and plates for 300 feet, rendering the first five compartments open to the sea. It is also important to note that, although the flooding was fatal, Titanic retained sufficient stability and didn't capsize. Remaining upright was vital for launching the lifeboats.

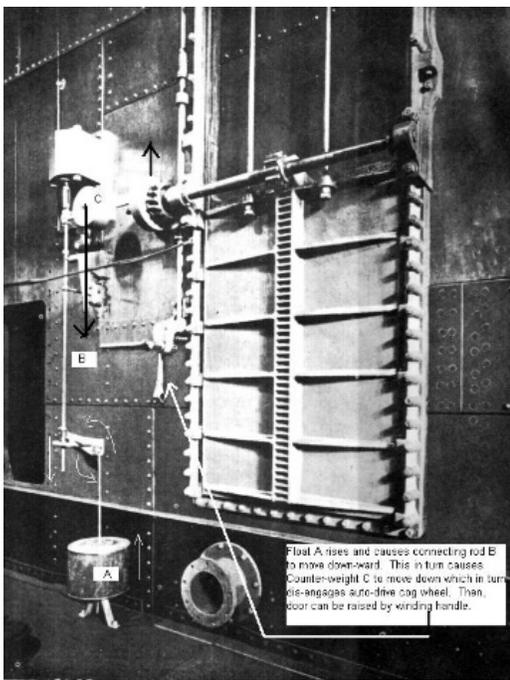
Vertical acting watertight door  
Credit: Encyclopedia Titanica

Titanic was privately funded by the White Star Line and wasn't designed for naval service. She was therefore built without a watertight deck, a feature found in warships and merchant vessels built with British government subsidies and meant to serve as auxiliary cruisers in time of war. As Titanic's bow sank deeper, the bulkheads were overtopped and flooding progressed unabated. The bulkheads were fitted with watertight doors to provide easy access between the compartments and close the bulkheads in the event of an accident. Watertight doors in the bottom of the compartments operated vertically by gravity, while those above operated laterally and were cranked closed manually by stewards assigned to the task.

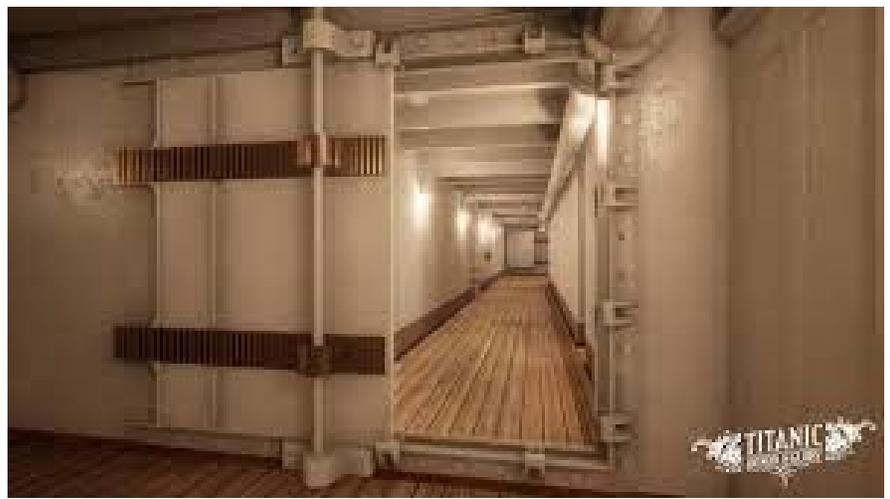
Lateral acting watertight door  
Credit: Titanic Honor and Glory
